FACILITY STATUS CHANGE FORM

Date Submitted: 1/14/2013 Originator: David Warren Phone: 539-6040	Area: 100-N Facility ID: 108-N Chemical Unloading Facility Action Memorandum: 100-N Ancillary Facilities	Control #: D4-100N-0024
--	--	-----------------------------------

Attachment 1: Facility Information (10 pages)

Attachment 2: Photographs (3 Pages)

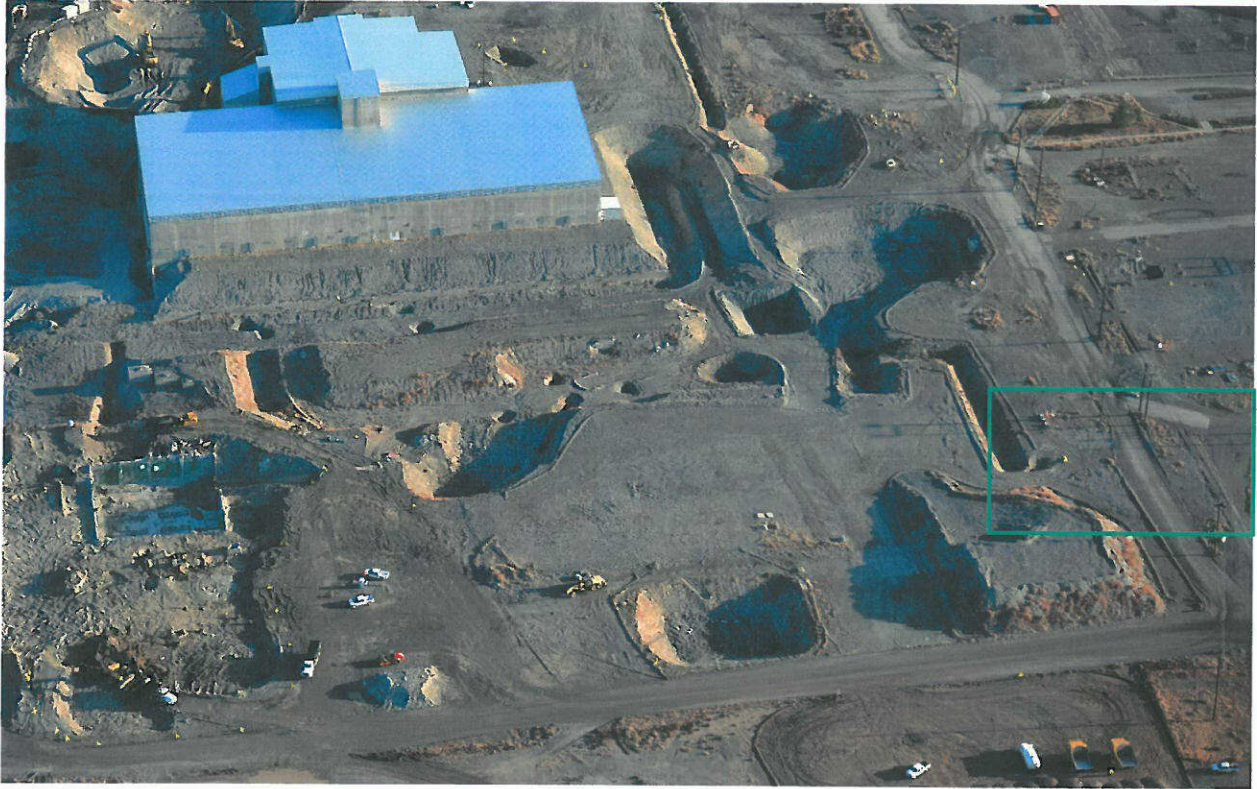
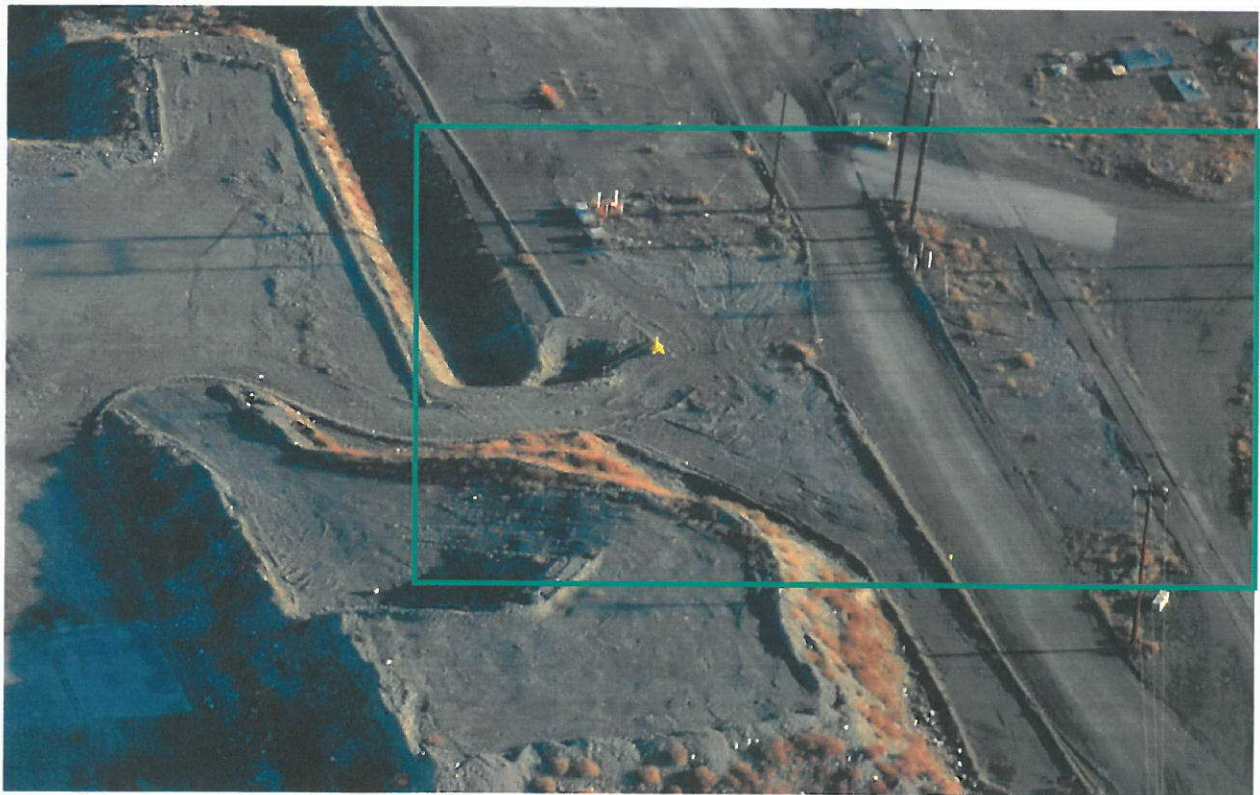
108-N After Demolition & Backfill

Demolition of the 108-N Chemical Unloading Facility was completed by December of 2008. Facility debris was sent to the ERDF for disposal. The excavation was subsequently backfilled with clean soil from the 100-N Borrow Pit.
